Water Solutions, Inc.

Date: May 5, 2017

Re: Acid Sump Area, Source Area Soil Excavation Construction Report

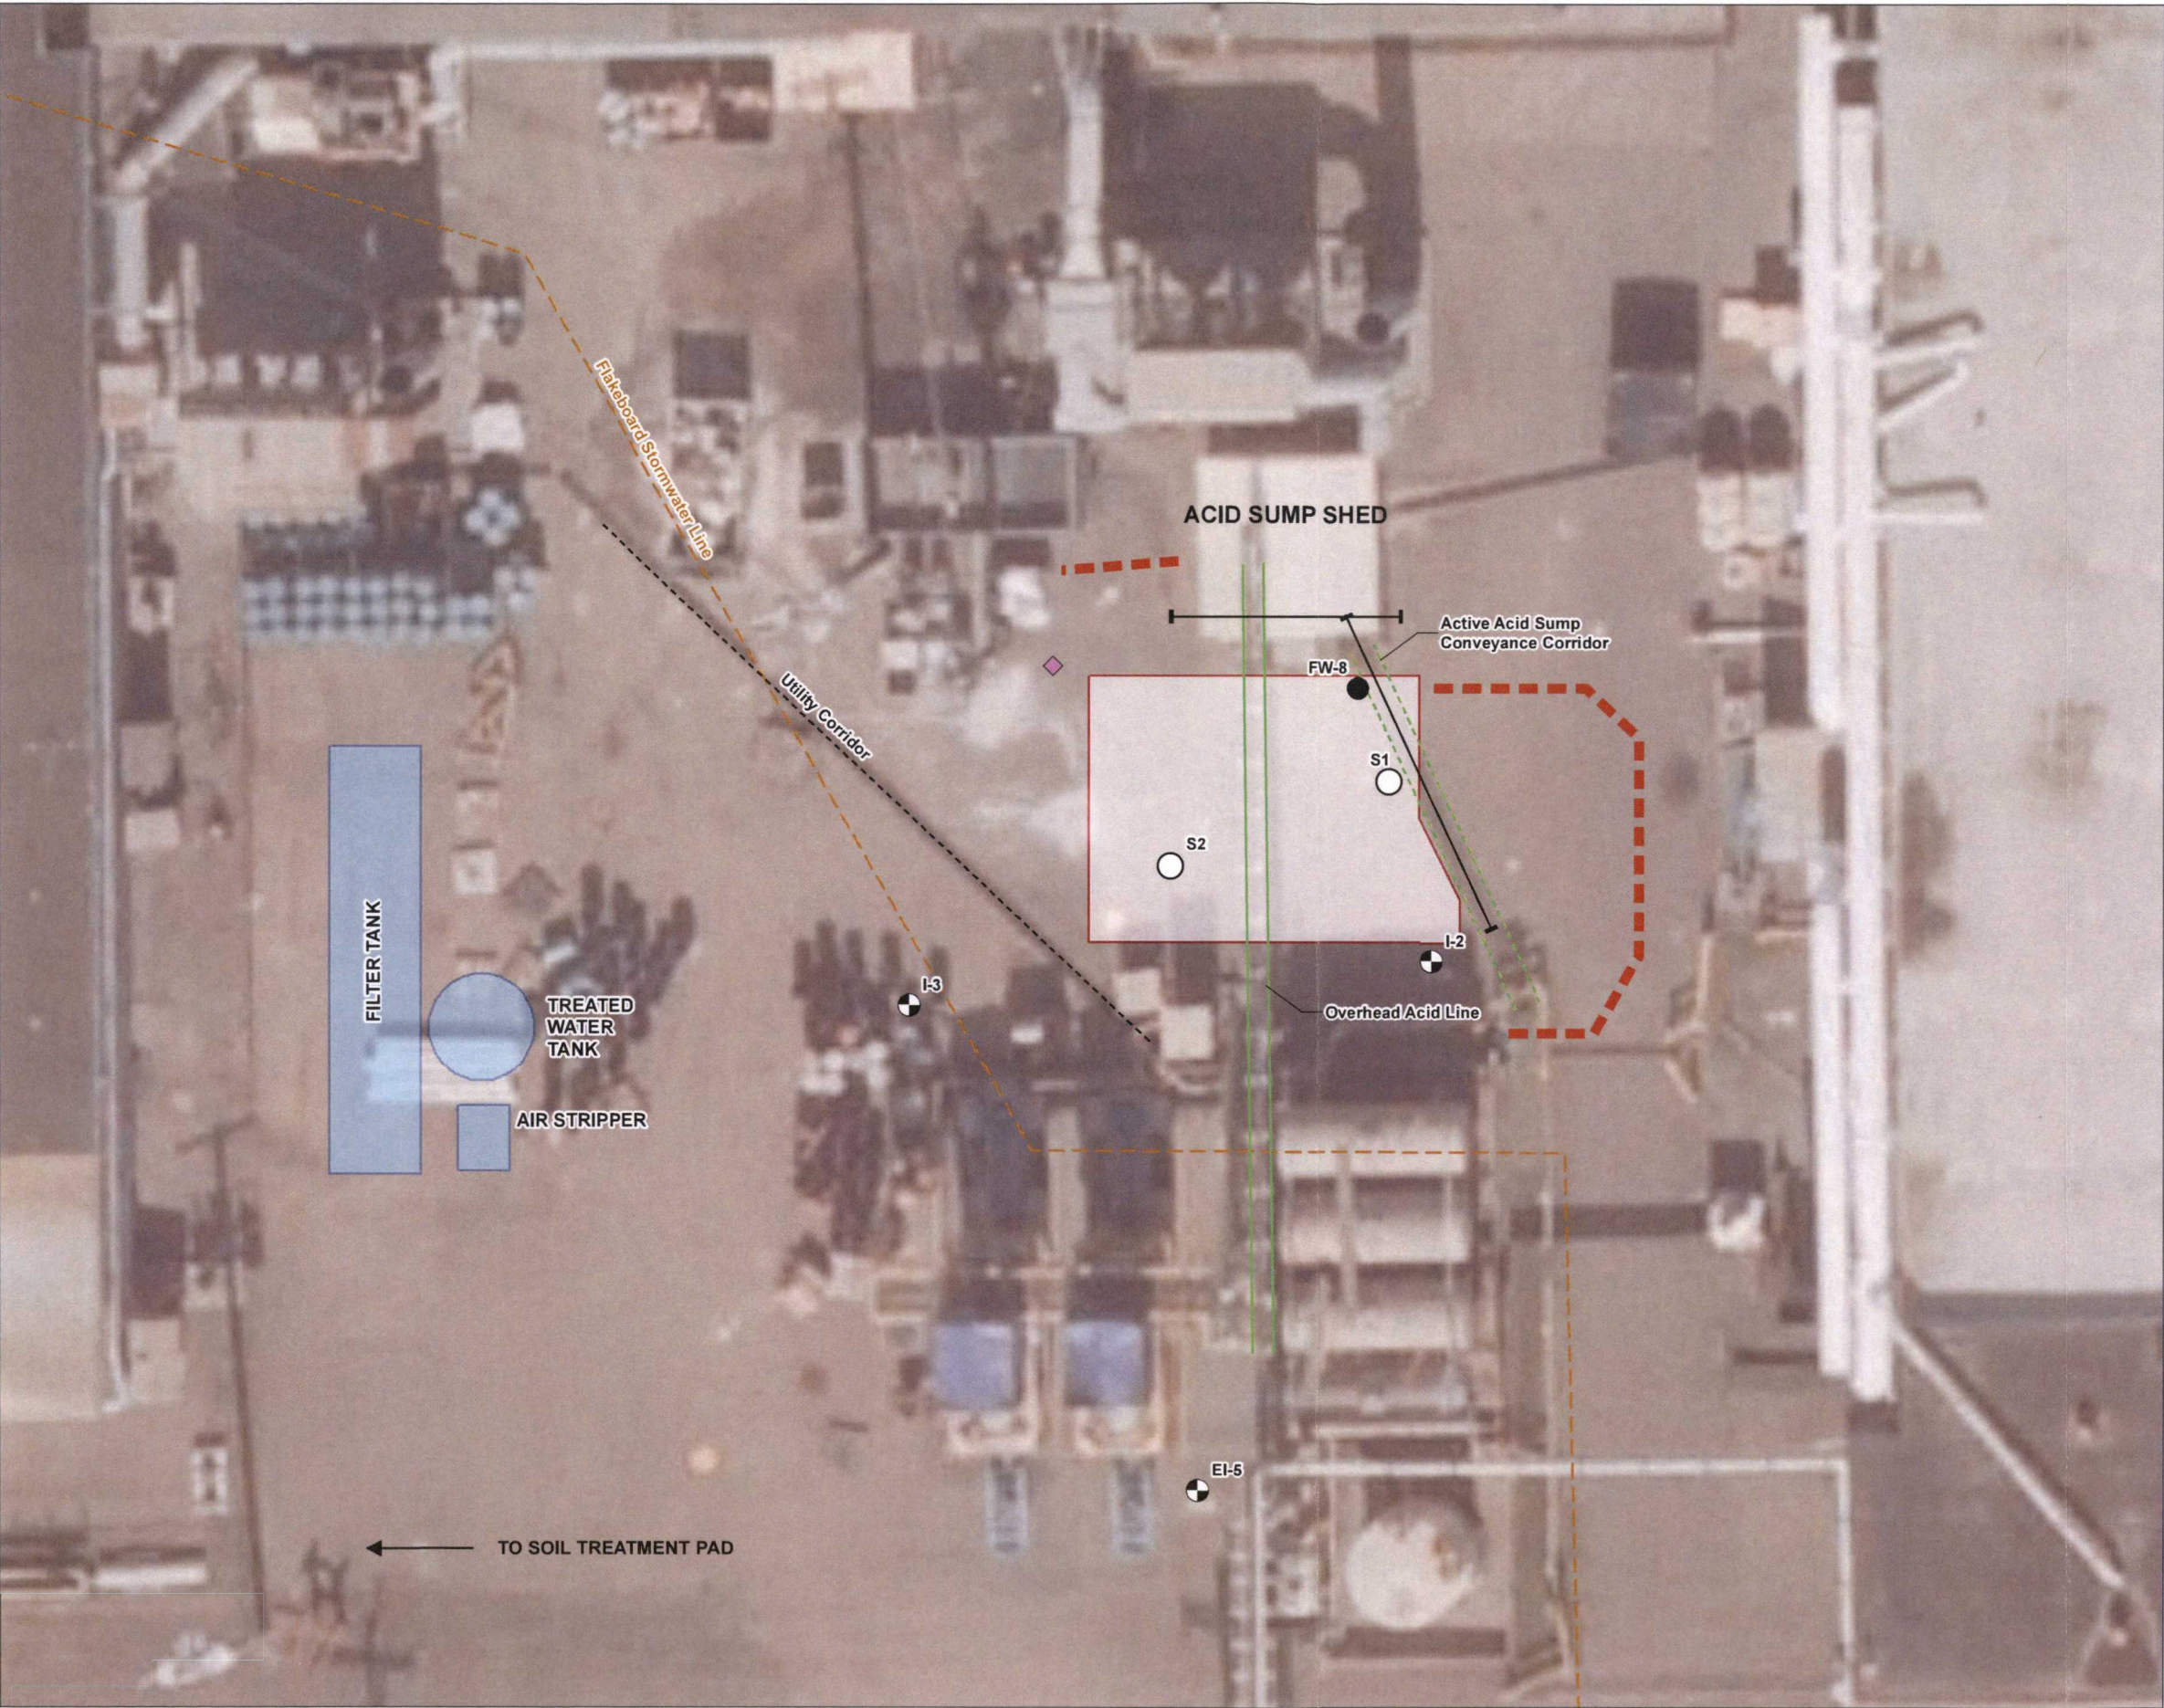
FIGURE 2

Excavation Area Layout

NOTE:
¹ I-2, I-3, and EI-5 were added to the groundwater monitoring program to replace I-1, TMW-1, and TMW-4 which were abandoned by excavation.

Groundwater extraction sumps for dewatering the excavation were installed during the week of July 20, 2016. Temporary monitoring well TMW-1 was converted to sump S1 (see Figure 2) and monitoring well I-2 was converted to sump S2. These two wells were within the footprint of the excavation and thus intended for abandonment. The advantage of over-drilling them and converting them to sumps was the decreased likelihood that the drilling would encounter obstacles during the installation. The sumps were installed by Steadfast Services, an Oregon licensed driller, and completed approximately 6 inches into the underlying Spencer Formation. The 8-inch-diameter slotted polyvinyl chloride (PVC) sumps were installed with a 12-inch hollow stem auger and surrounded with pea gravel as a filter pack. The sumps were fit with submersible pumps and plumbed to a GWTP. Sump operations and details are presented Section 6.

- The components of the GWTP were clustered closer together to protect and minimize the plumbing connections (see Figure 2 versus Figure 4-1 of the Work Plan).
- Well I-1 was used instead of TMW-4 for the installation of sump S2 because it is located closer to the perimeter of the excavation and would interfere less with the operation of the excavator.

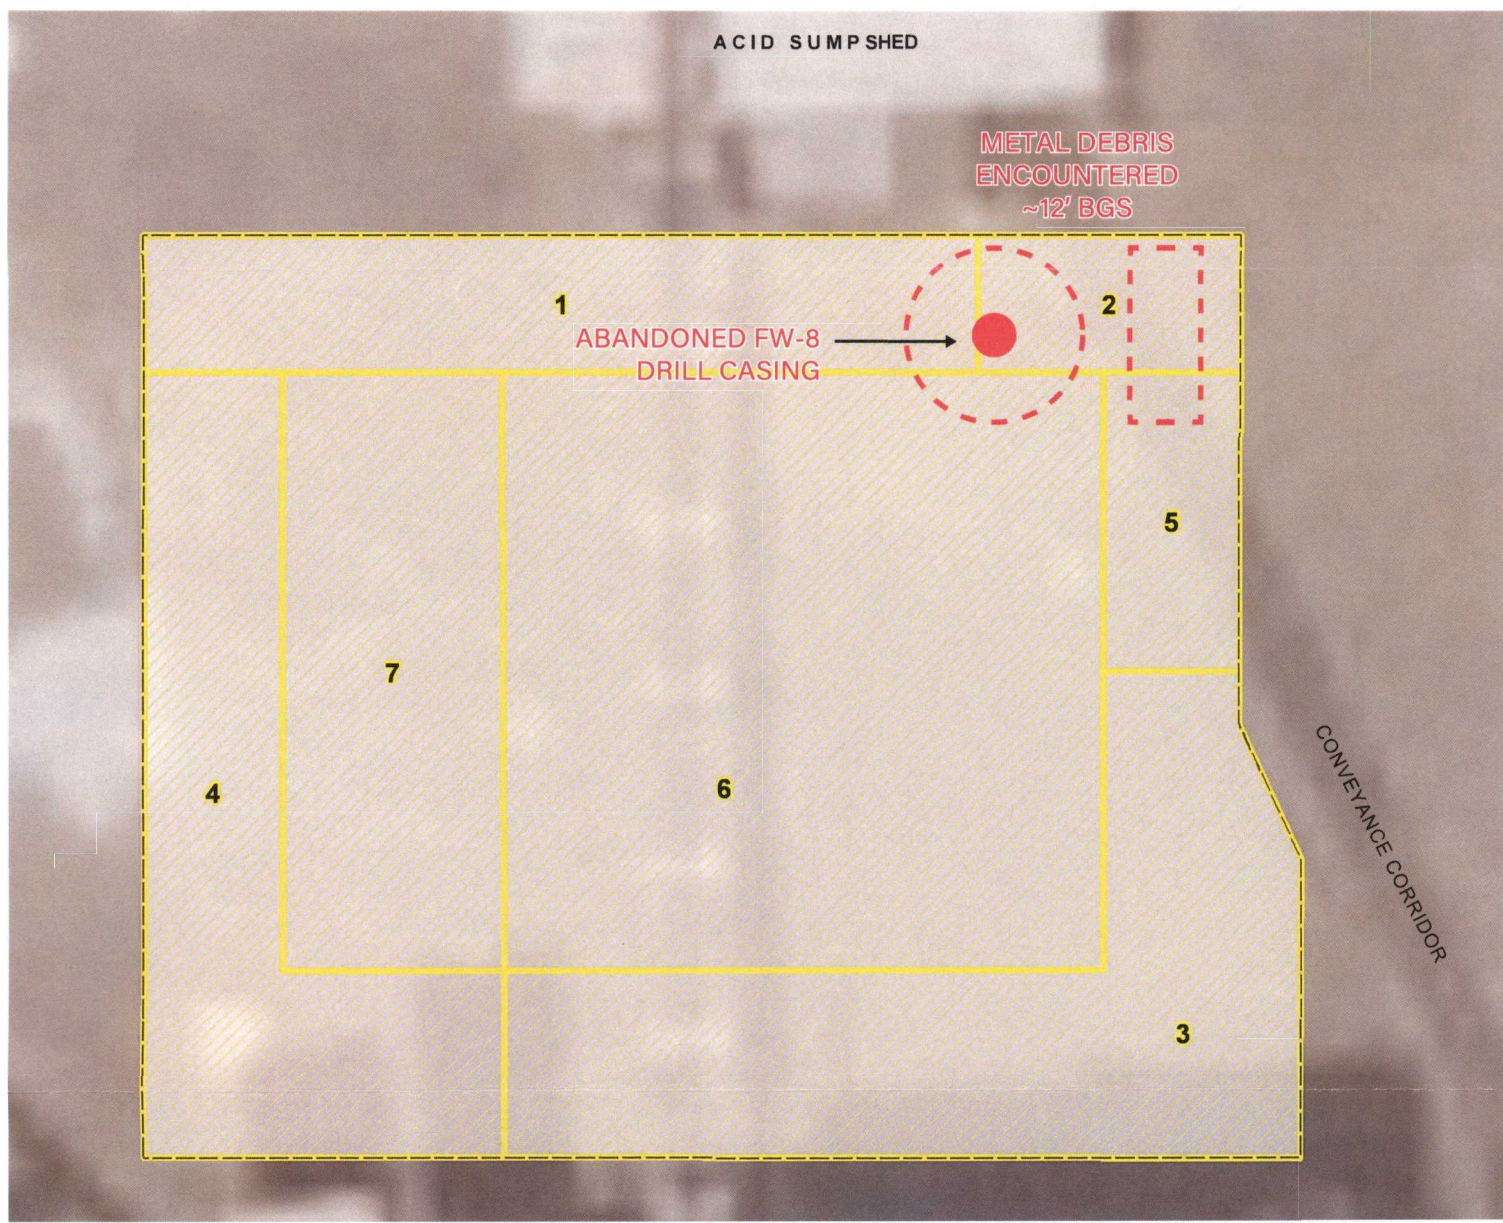
CROSS SECTION

PLAN VIEW

**FW-8 Obstruction
Excavation Sequence**
Acid Sump Source Area Excavation
ATI Millersburg Operations, Oregon

After the perimeter segments were completed, the central segments (6 and 7) were excavated to depth at the same time, then backfilled. Drain rock, chemical oxidant, and filter rock were placed in the bottom of the hole similar to the perimeter sections, then $\frac{3}{4}$ -inch minus rock was applied in approximately 12-inch lifts and hoe-compacted to ground surface. Table 1 presents an overview of activities by day and excavation segments are shown in Figure 3.

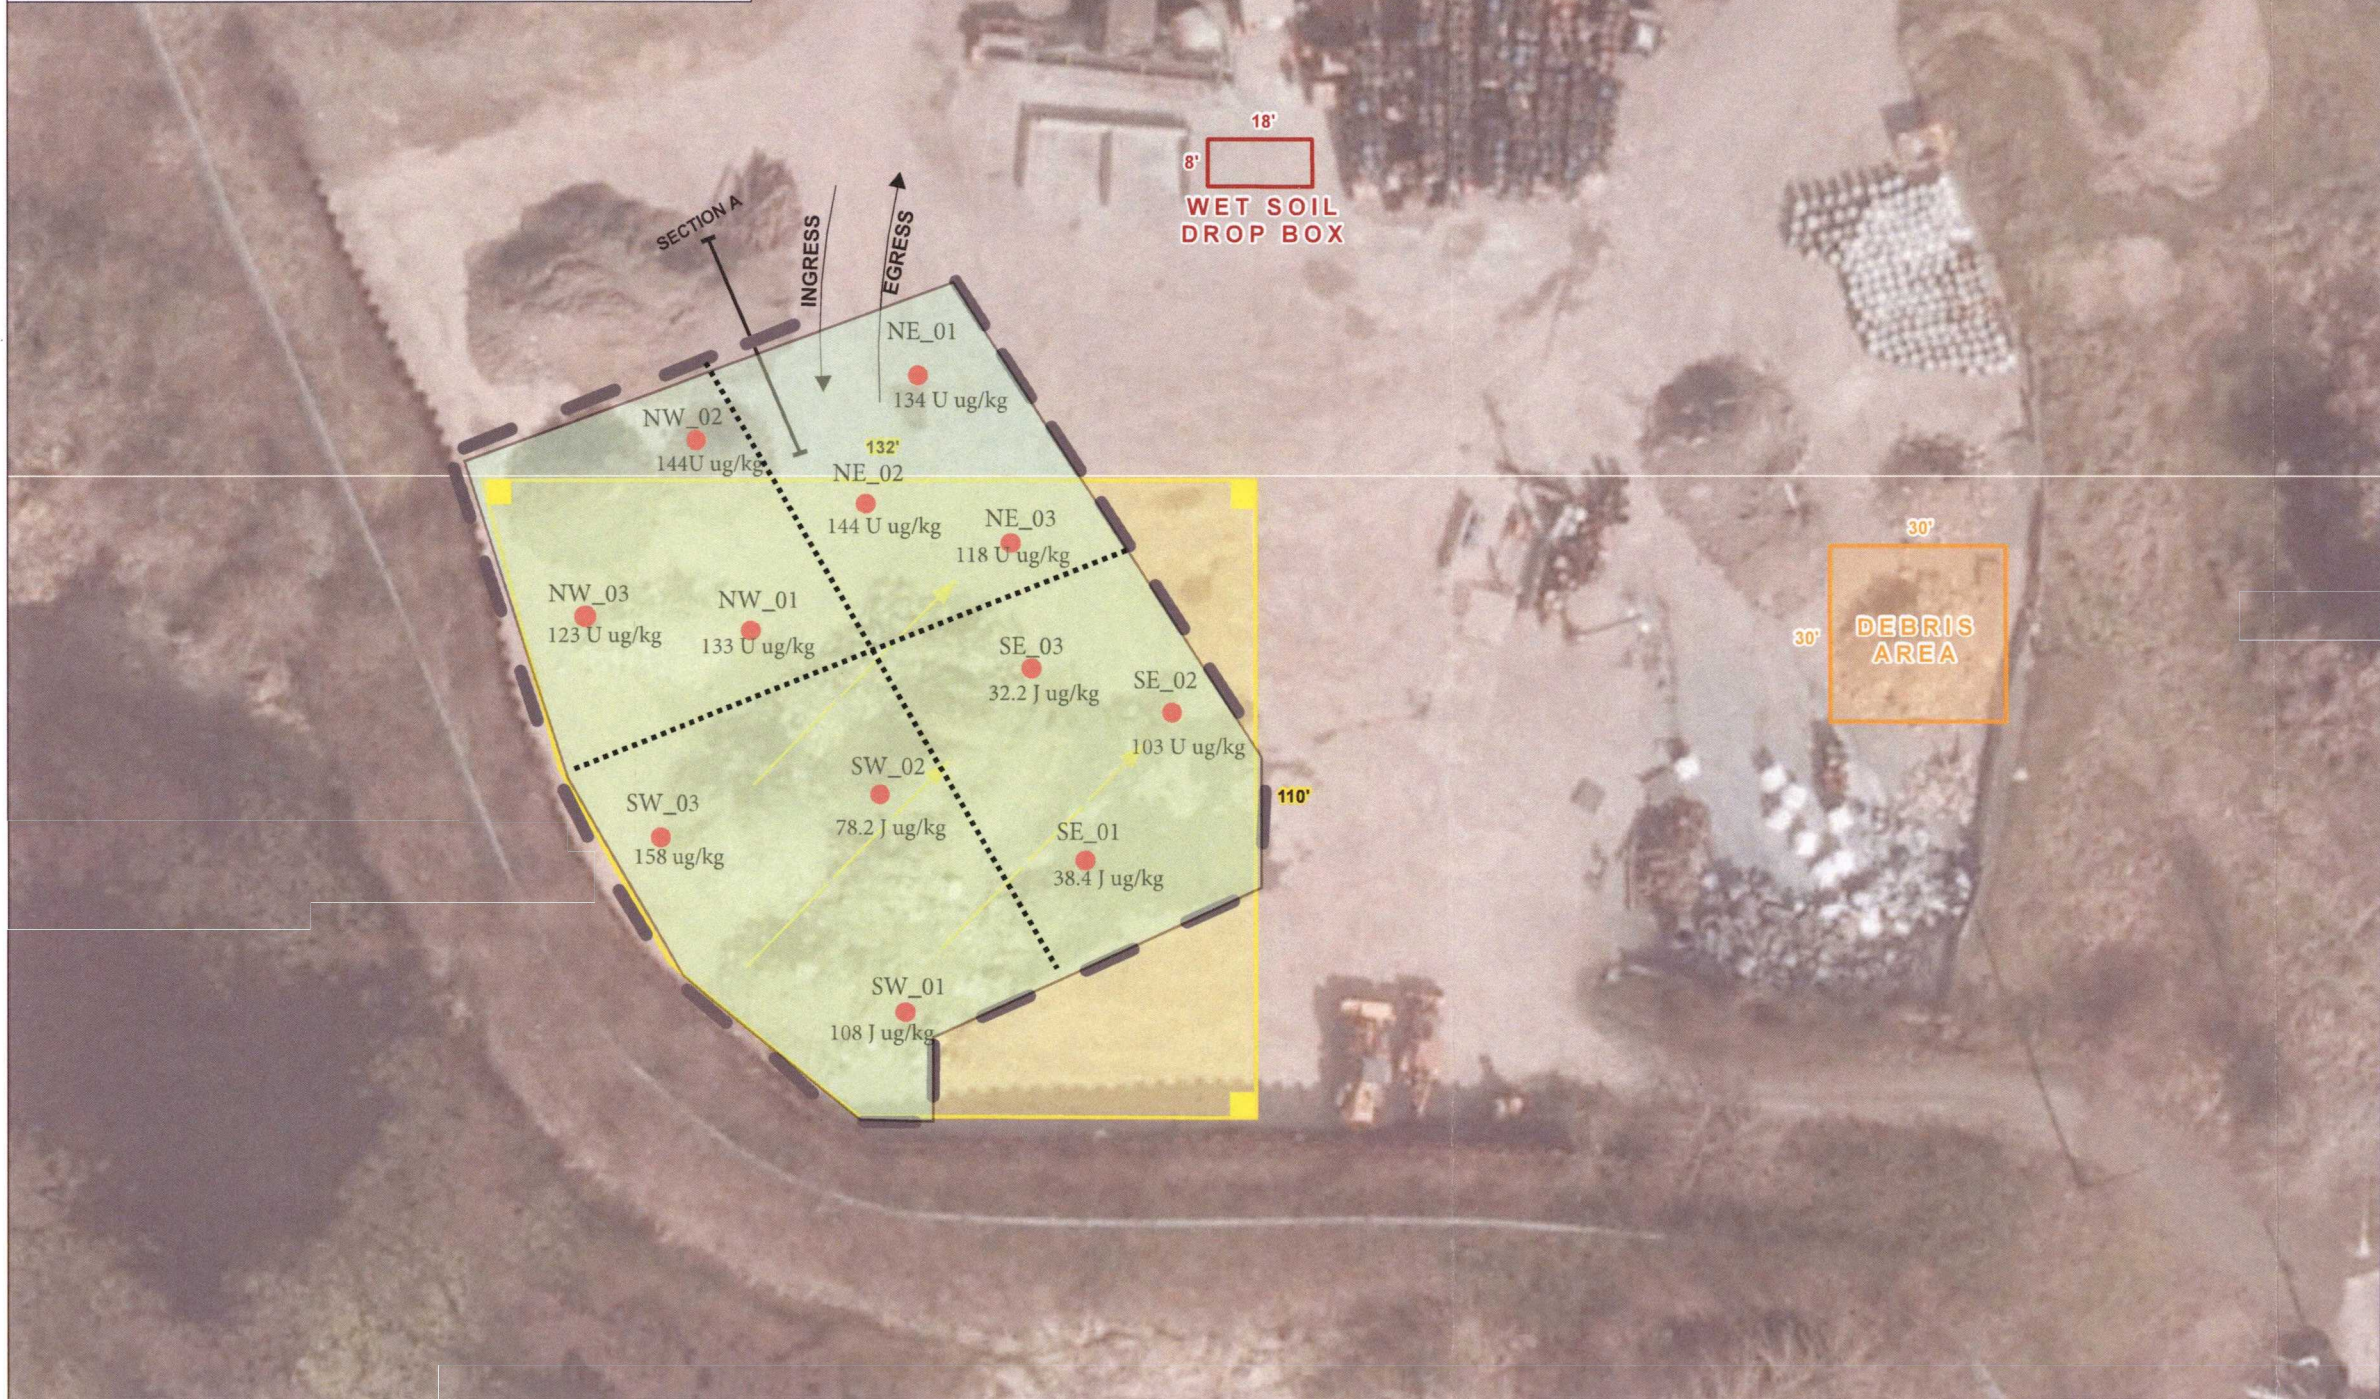
FIGURE 5
As-Built Soil Treatment Pile
& Confirmation Sample
Locations
Acid Sump Source Area Excavation
ATI Millersburg Operations, Oregon

Soil samples were collected from the soil treatment pile on August 31, 2016. Three discreet samples were collected from each quadrant of the pile for a total of 12 analytical samples. The sample location and identification labels are shown in Figure 5.

- ¹ Sample locations are presented in Figure 5. Samples were collected from northeast (NE), northwest (NW), southeast (SE), and southwest (SW) quadrants of the soil treatment pile on August 31, 2016
- ² Sample concentrations are presented in micrograms per kilogram (µg/kg)
- ³ Target treatment concentrations are RCRA hazardous waste disposal and treatment standards
- ⁴ Land disposal requirements from RCRA §268.48

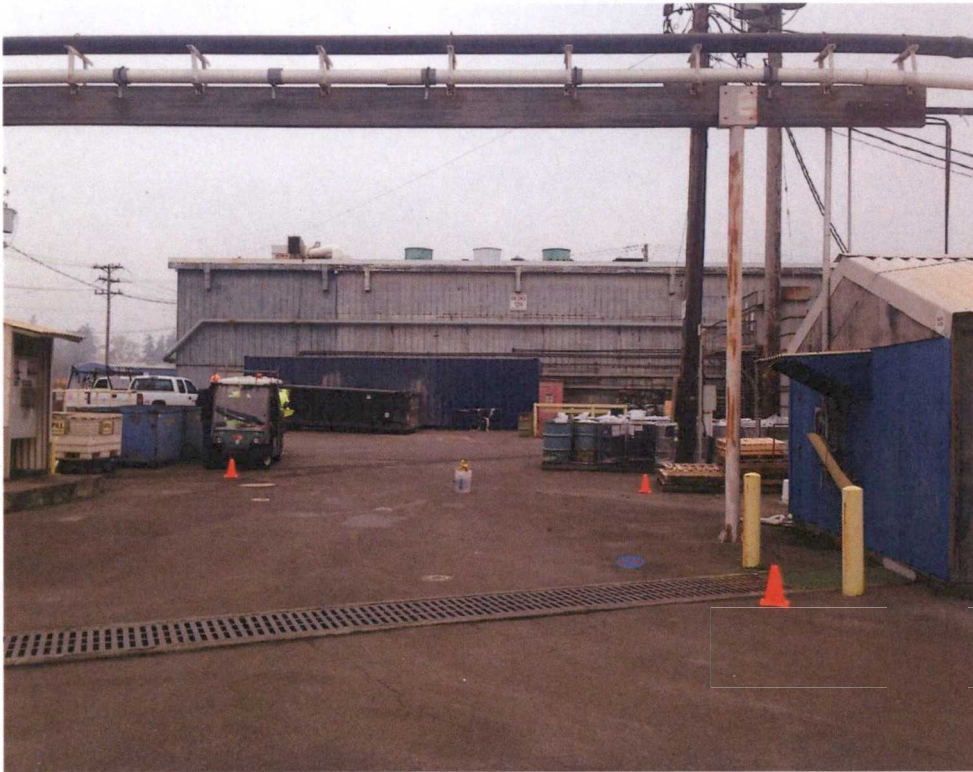
Photo 1. Pre-excitation layout with area roughly delineated by orange cones. Sub-surface conveyance corridor in the foreground leads to the acid sump, which is covered by the blue shed to the right. The overhead acid utility runs along the top of the photo. Approximate location of former FW-8 indicated by blue and red marker (West Camera Direction).

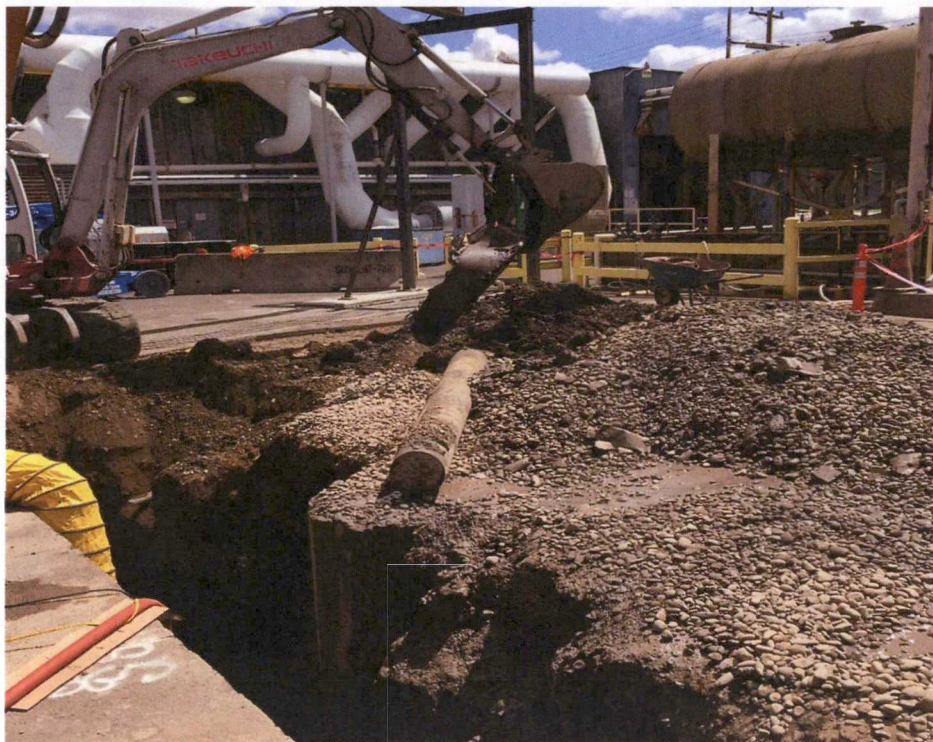
Photo 3. Excavator removing pickling basket, or metal debris from below 2007 attempted well FW-8. Metal pipe lying on the ground in front of the excavator bucket is the abandoned FW-8 sonic drill casing (Southeast – Segments 1 and 2).

In 2007, when the driller intercepted the TCA source while attempting to install extraction well FW-8, the steel drill rod was abandoned in the borehole. During the excavation in Segment 1 the excavator followed the steel drill rod down to the bottom of the hole while disturbing it as little as possible. Various abandoned piping, concrete blocks, and debris were encountered through the course of the excavation. Two 5-foot-diameter by 2-foot-high circular steel scraps were found at the bottom of the hole that may have been pickling baskets. There were no other metal scraps, metallic debris, or segments suggesting that an underground tank had ever been present at the Site. One of the metallic scraps was found atop the Spencer Formation at the bottom of the hole and at the end of the abandoned drill rod. It is conjectured that debris may have acted to retain source material at some point, similar to a cup. A conceptual drawing of the metal debris and its location in the excavation are presented in Figure 3. A photograph of the metallic object brought to the surface is presented in Attachment B.

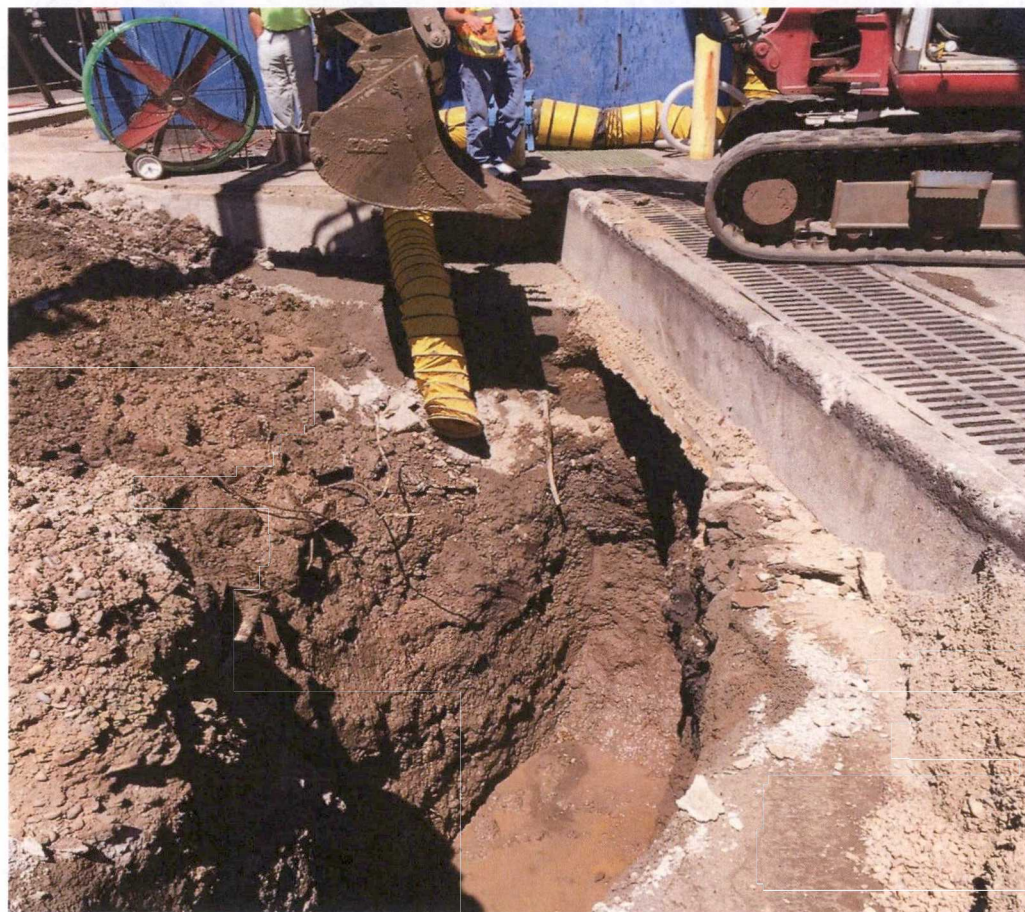
Photo 4. Digging along east wall in Segment 5 (see Figure 3) after concrete perimeter fills in Segments 2 and 3. Yellow in-line blower exhausts air from excavation. Soil samples collected from this excavation wall at 6-feet and 12-feet below ground surface (North)

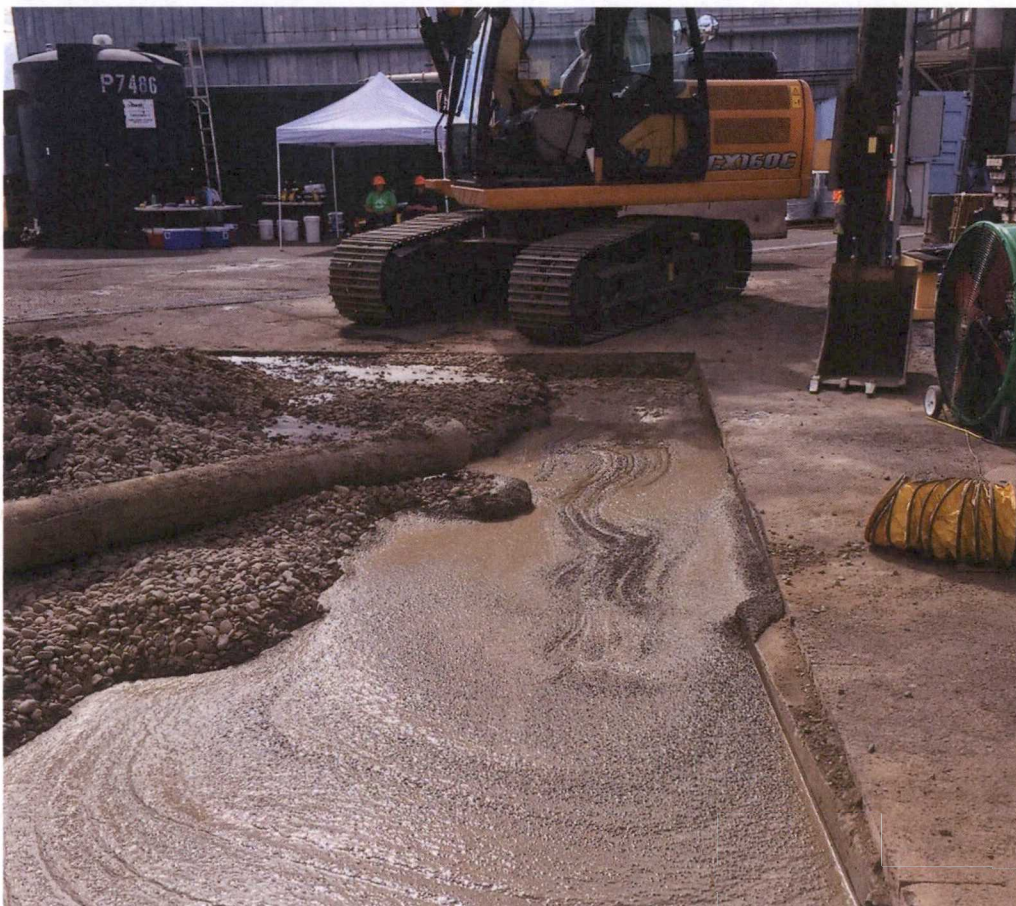
Photo 6. Completion of the CLSM fill along the north wall of the excavation in Segment 1. 'Pipe' on the ground in front of the excavator is the abandoned drill casing from attempted well FW-8 in 2007. Tank in upper left (P7486) is the 6900 gallon treated-water tank (West).

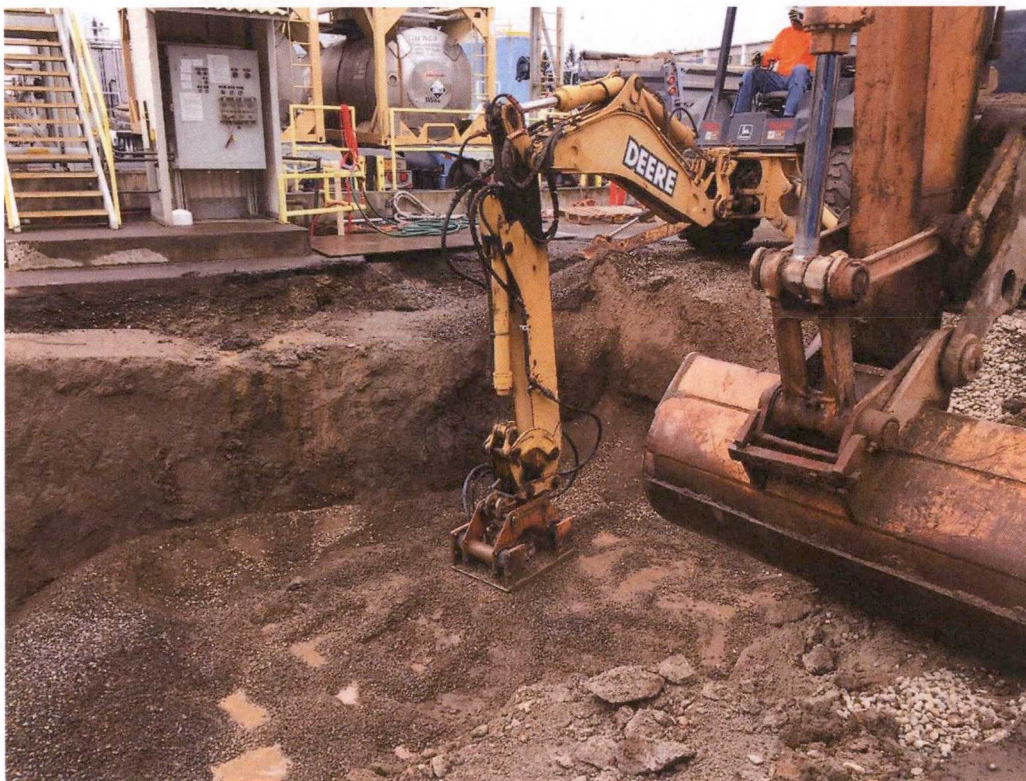
Photo 8. In central Segments 6 and 7 the $\frac{3}{4}$ -inch minus filter rock was added in 1-foot lifts and hoe-compacted to ground surface (Southwest).

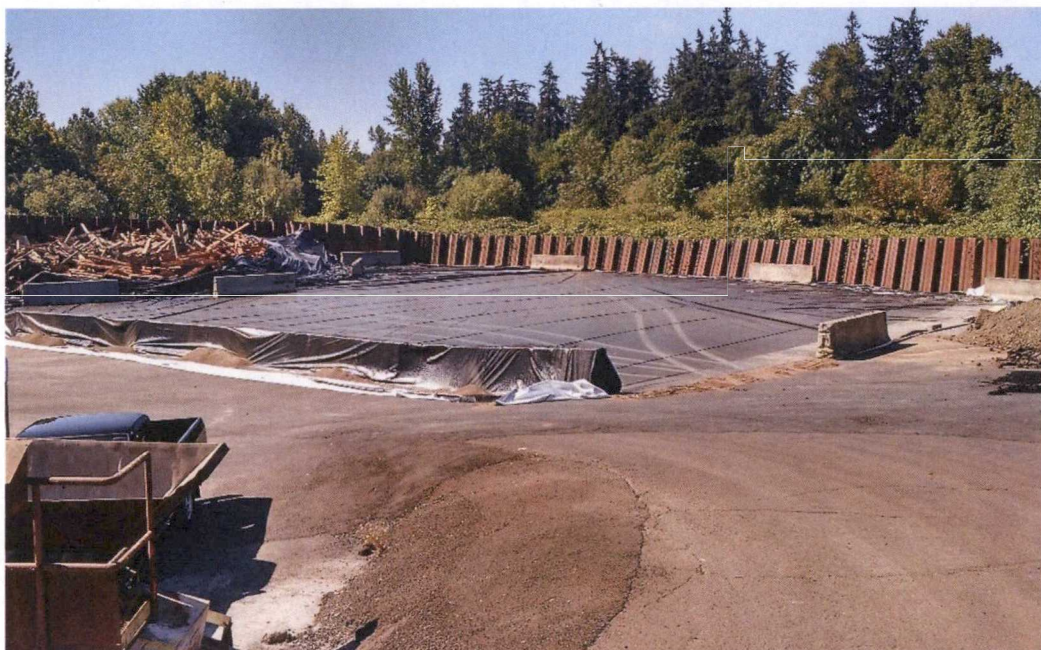
Photo 9. Construction of the soil treatment pile with pre-fabricated 8-mil low-density polyethylene scrim liner 144-foot wide by 160-foot long. Edges of liner were draped over concrete jersey barriers to contain any potential runoff from leaving the pad (Southwest).

The soil treatment pad occupied approximately 12,000 square feet in the southeast section of the SLEP. A prefabricated 144-foot x 160-foot x 8-mil low-density polyethylene (LDPE) scrim liner provided by Northwest Linings and Geotextile Products of Kent, Washington, was unfolded and spread over the SLEP asphalt base by a five-person crew. The edges of the liner were secured by draping them over jersey barriers, which provided hydraulic control from potential runoff or erosion.

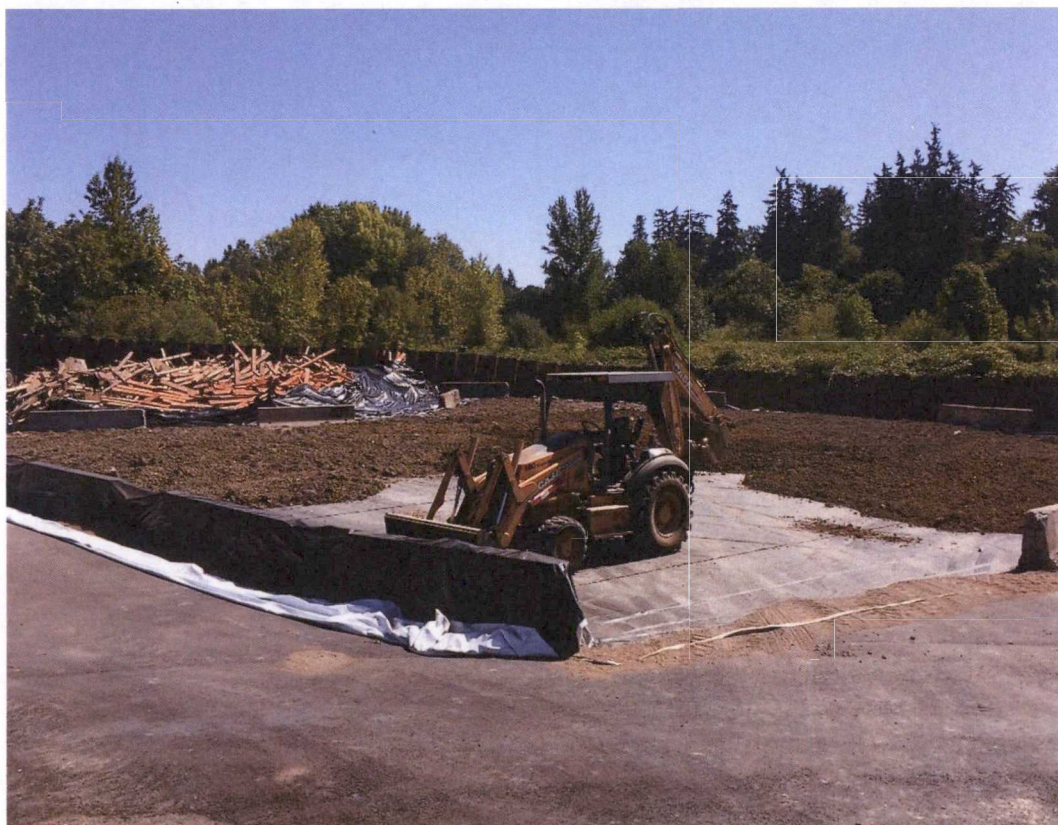
Photo 10. Base layer of the treatment pile was constructed using PID-screened soils. Excavator bucket with tines was used to evenly distribute and mix soils in the treatment pile (Northwest).

- Excavated soils with less than 70 ppm were used as a base layer for the pile.
- Soils with PID readings greater than 70 ppm were placed on top of the base layer.
